Chicora Foundation, Inc.

Memo

To: Mr. John Parker
From: Michael Trinkley
CC:
Date: November 11, 2009
Re: Mansfield Plantation African American cemetery

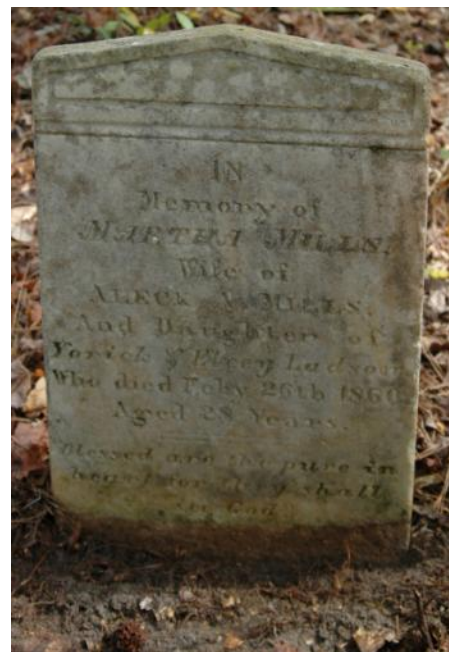
There is one grave dating prior to the Civil War. It reads, "In / Memory of / MARTHA MILLS, / Wife of / ALECK A. MILLS. / And Daughter of / Yorick & Elcey Ladson / Who died Feby 26th 1860 / Aged 28 Years. / Blessed are the pure in / heart for they shall / see God." A marble foot stone is marked "M.M. / 1860." The style of the marker is typical of those created by W.T. White, a Charleston stone cutter of the nineteenth century (Trinkley 1987:37-40).

Figure 4. Marble headstone for Martha Mills.

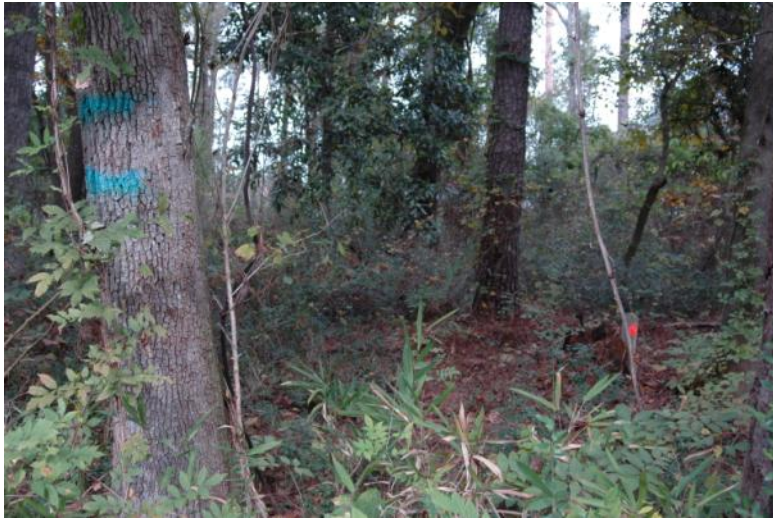
Figure 6. View of the Mansfield Cemetery looking east from the access road.

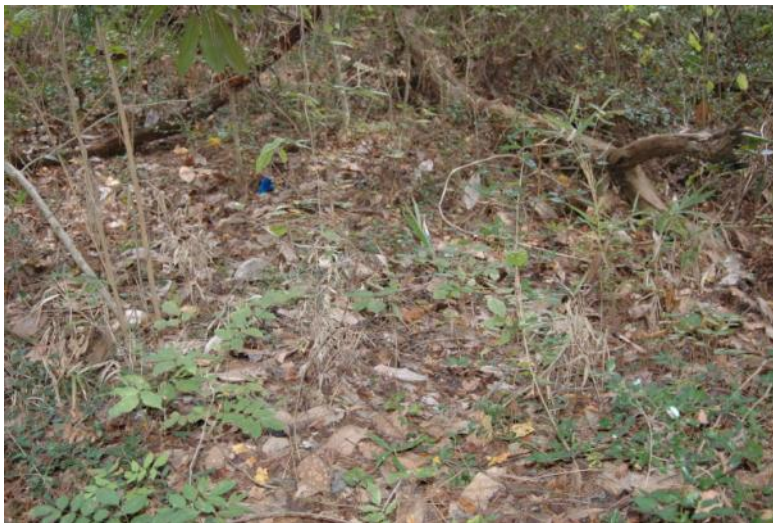
Figure 7. Example of grave depressions in the Mansfield Cemetery.

3. With the cemetery vegetation thinned, I recommend that the grave depressions, marked graves, and significant vegetation be mapped as a permanent record of the cemetery conditions. This is another task that we here at Chicora have done for a number of African American burial grounds. This cost would be about \$1,900.

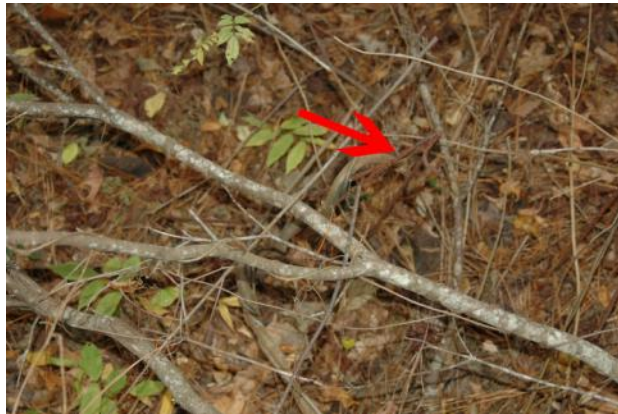
Figure 8. Example of a wire flower holder showing how it blends into the underbrush and could be easily overlooked.

2. The cleaning of the cemetery that is proposed is appropriate, but care should be taken to ensure that no burial evidence is damaged. During my visit I attempted to mark those items I recognized, but it is likely that additional metal funeral home plaques or metal flower stands will be encountered during cleaning – care should be taken to leave all of these items in-place. Vegetation such as briars and wisteria should be removed, as can trees under 2-inches dbh (except for cedars). I recommend, however, that the Beautyberry be left in place. Care should also be taken to disturb as little of the “duff” or leaf litter as possible, since there are known to be bulbs. All clearing should be by hand, with all debris removed from the cemetery by hand. It is especially important to prevent the cemetery from appearing “too” manicured or cared for. The cultural roots of the African American cemetery should be respected and the historic context of the cemetery retained.

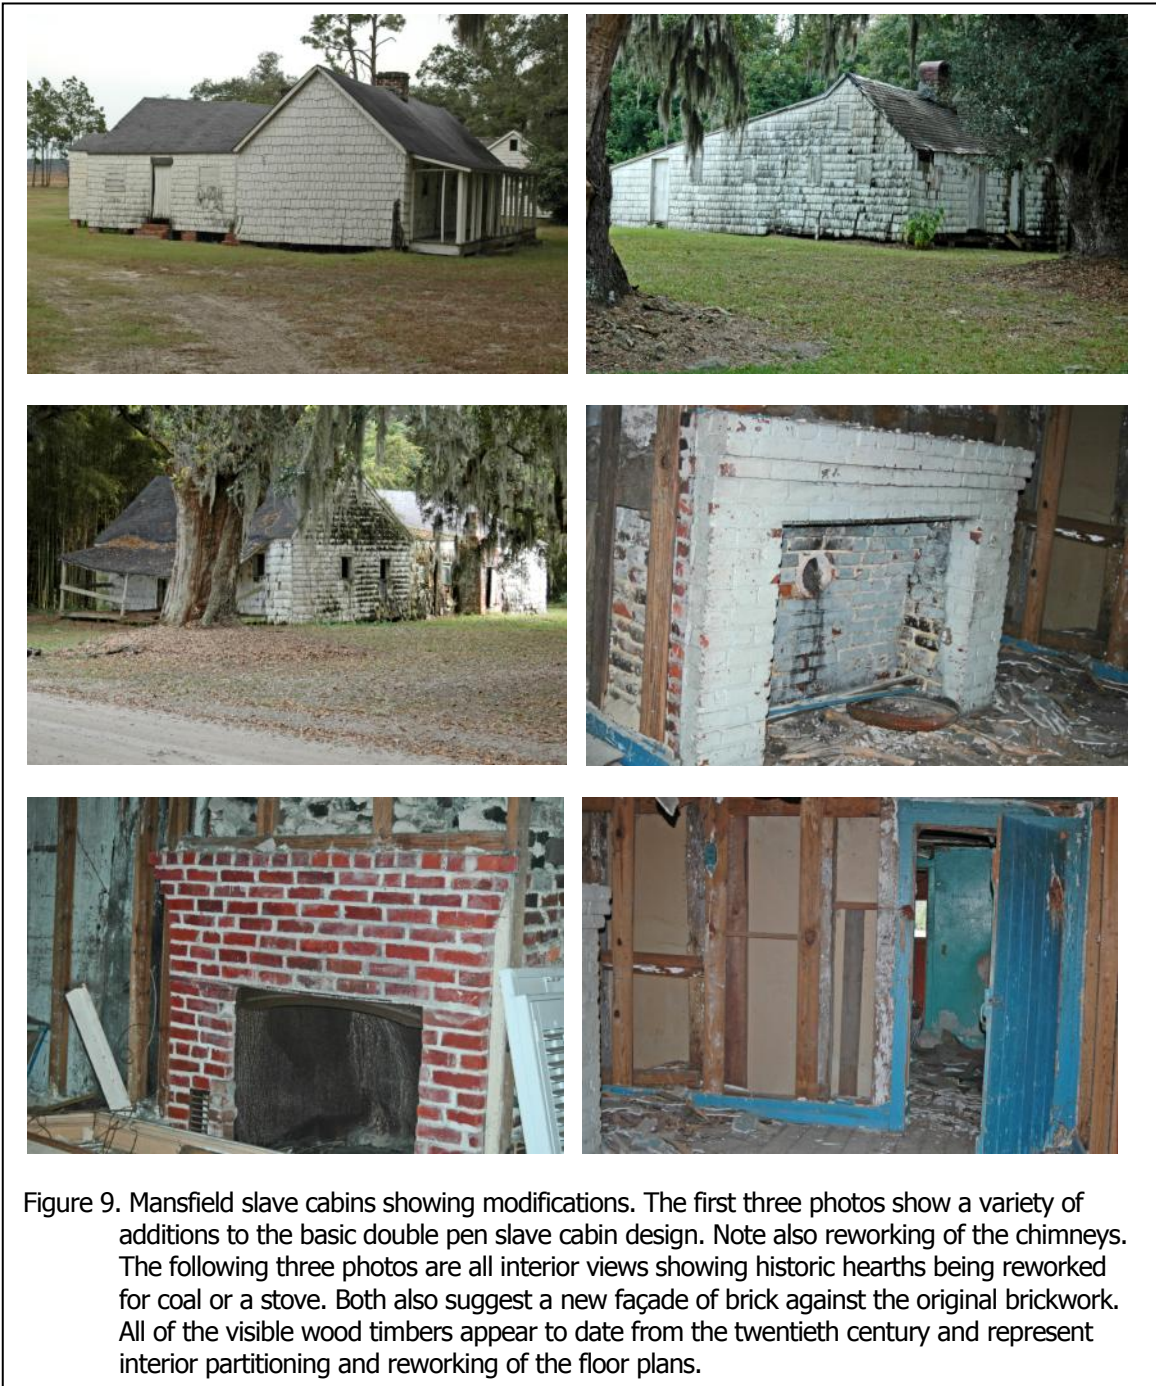
All of the structures I observed clearly showed evidence of multiple renovation projects. Each building has been extensively altered. For example, each appears to have been added on-to several times. Several that I could examine through windows appear to contain a great deal of "new" material, with basic reorganization of living spaces and extensive reworking of the chimneys and hearths. At first

Figure 9. Mansfield slave cabins showing modifications. The first three photos show a variety of additions to the basic double pen slave cabin design. Note also reworking of the chimneys. The following three photos are all interior views showing historic hearths being reworked for coal or a stove. Both also suggest a new façade of brick against the original brickwork. All of the visible wood timbers appear to date from the twentieth century and represent interior partitioning and reworking of the floor plans.

glance it appears difficult to clearly determine what is historic fabric dating to ca. 1860 and what has been added since that time.

The deterioration of the remaining structures is severe and without near-term intervention the long-term preservation of these structures may be impossible. The work necessary to even stabilize these structures may not be available. Therefore, I strongly recommend that a team of an architectural historian and archaeologist examine each of these structures and prepare detailed notes, drawings, and photographs in order to document the historic core of these structures. While this is not an

inexpensive undertaking, it is certainly less costly than restoration – and it would serve to ensure that critical information is collected for future generations.

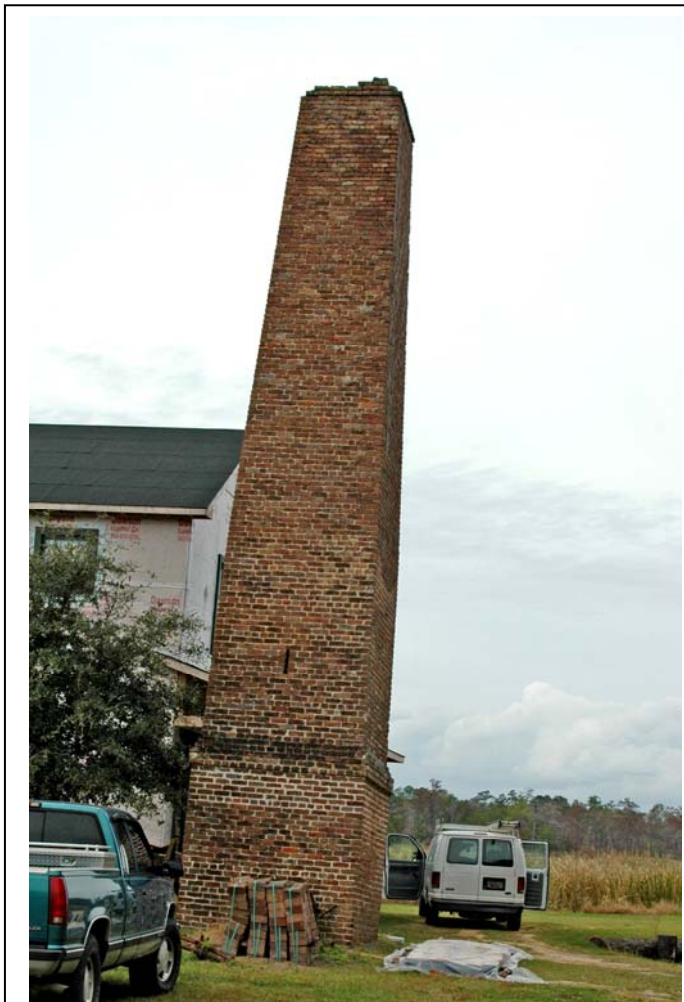
Although I was not specifically tasked with examining the rice mill chimney, when I observed it during my examination of the slave settlement I thought it was worth a closer inspection. What attracted my attention initially was what appeared to be a significant lean. I realize that this can sometimes be an optical illusion, so I hung a plumb bob on the chimney's north side at a height of about 6 feet above grade. I found that the chimney is out of plumb by about 4" over this 6' drop.

I also observed several cracks radiating up the chimney on the north side, with less significant cracks on the east, west, and south sides.

The chimney has also lost several courses of brick at the top, as seen in Figure 10.

There appears to have been several efforts at repointing. Figure 10 shows six repointed courses and additional pointing is found below this and in several other areas. While the

Figure 10. Rice mill chimney showing a serious lean.

mortar color match is unsatisfactory, the mortar application is generally good and the mortar appears to be relatively soft. However, there remain a number of heavily eroded joints that require attention.

It is relatively easy to provide specifications for repointing – and Chicora even does this work. However, prior to doing any further pointing, I strongly recommend that the chimney be evaluated by a structural engineer with experience in historic preservation activities. If the Mansfield Foundation

A structural engineer can assess the probable cause of the lean, evaluate its severity, and most importantly, provide recommendations on corrective measures should they be necessary. In the meantime, I recommend that several crack gages be placed on the chimney to

allow the structural engineer to determine if there is active movement. One source is Preservation Resources Group (<http://www.prginc.com/Masonry/PRG-crackmon.html>).

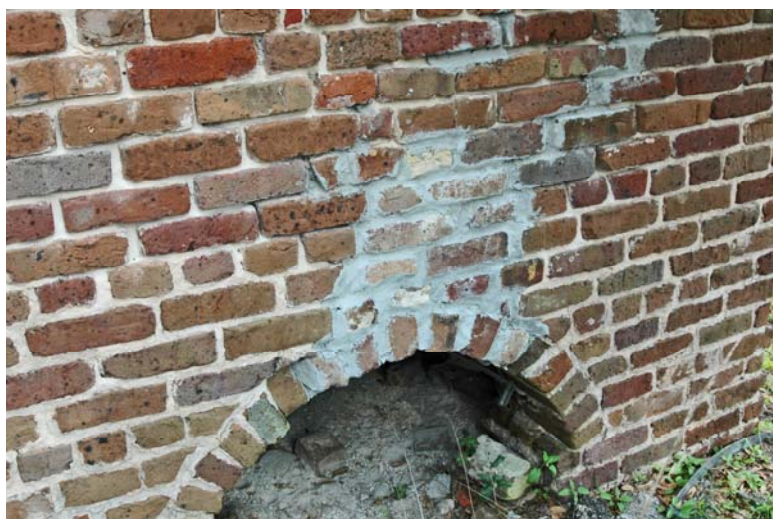
There is also pointing around the fire box on the north elevation. This work is unsatisfactory. A very hard gray Portland cement mortar has been used. This mortar will lead to the deterioration of the surrounding brick and should be removed. In addition, the workmanship is sloppy and it disfigures this otherwise beautiful example.

Figure 11. Example of bad pointing around the chimney firebox. This work should be removed and repointed once more critical structural issues are resolved.
